Echo Analysis Case Study

The following case study describes how Cisco worked with an enterprise customer to eliminate echo in a VoIP network. The customer is a large manufacturing company with headquarters in Reading, Pennsylvania, and several plants in the United States and overseas. One plant, located in Brussels, Belgium, previously used the PSTN for intersite calling, which resulted in high toll charges. Because the customer already had a data network in place, the logical choice was to implement a combined voice and data network. Because traffic at the headquarters was required to cross the Ethernet backbone to the PBX, the customer decided to use IP for voice traffic. It was calculated that the customer would save \$3000 a month by installing three voice trunks across the data infrastructure.

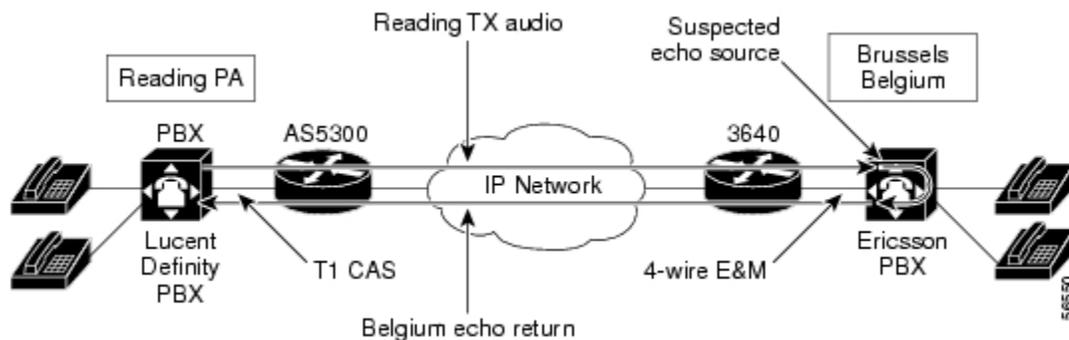
Figure 2 Echo in Customer Topology

Eventually we discovered that a hybrid in the tail circuit was converting signals from 4-wire to 2-wire. Hybrids can be a common echo source. [Figure 2](#) shows how the hybrid was deployed in the customer's network.

We explained to the customer that the echo problem probably existed before VoIP was implemented but that it had not been perceivable because the PSTN delay was below the noticeable threshold. Packet-based networks create some small delays (as a result of packet encoding, queueing delays, and jitter buffers) that might unmask preexisting echo problems. This condition is normal and is characteristic of a packet-based network.

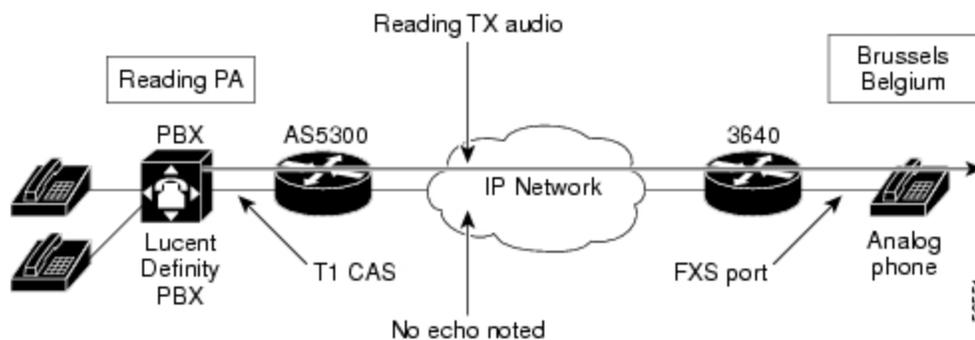
Figure 3 FXS Test Configuration

Assistance Center (TAC). We instructed the customer's on-site personnel to install and configure the FXS module in the existing Cisco 3640 to allow calls from the FXS port on the Brussels 3640 to the PBX in Reading. When we established calls between the Brussels 3640 and the PBX in Reading, there was no perceivable echo and the quality was very clear.

This test indicated that if the 4-wire to 2-wire conversion occurred on the router (as opposed to the Ericsson PBX), no echo was present. Therefore, the Ericsson PBX was most likely causing the echo. The simplest solution to such an echo problem would be to connect only FXS ports from the Cisco 3640 into the PBX. This configuration would allow the router to perform the 4-wire to 2-wire conversion, and the FXS ports would appear as central office (CO) trunks to the Ericsson PBX. Although this configuration would not provide as much flexibility as the 4-wire E&M trunks, it would not take away any functionality from the customers because they used an auto-attendant. [Figure 3](#) shows this FXS test configuration.

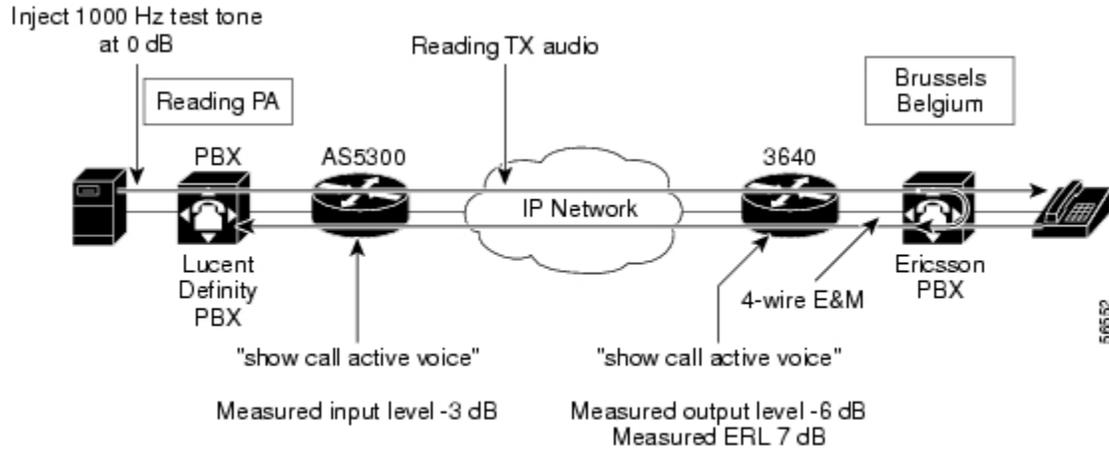
Figure 4 Audio Level and Echo Test Setup

After we verified the proper audio settings on the Reading router, we entered a **show call active voice EXEC** command on the Cisco 3640 in Brussels. This router displayed a -7 dB audio setting heading toward the Ericsson PBX. Even though the -7 dB level itself was acceptable, the optimal level is -12 dB at the phone on the PBX because different PBXs have different loss levels. [Figure 4](#) and [Table 1](#) depict the level adjustment configuration and the levels that were seen.

We applied the same 1004-Hz tone at 0 dB to the Reading PBX and then we again entered the **show call active voice** EXEC command to display the ERL level. The ERL represents the level of the echo coming out of the PBX in relation to the signal into the PBX. Notice that in [Table 5](#) the ERL level is -14 dB, which means that, in relation to the signal going into the PBX, the echo is coming back at a level only *7 dB less* than what was going in.

The International Telecommunication Union Telecommunication Standardization Sector (ITU-T) recommendation G.131 states that the ERL of a PBX should be greater than 15 dB. The ERL was substantially higher than an echo canceler can effectively nullify; therefore, the echo problem was with the Brussels PBX. To further verify the problem location, we adjusted the audio level into the PBX up and down. When we adjusted the audio level, the ERL remained constant.

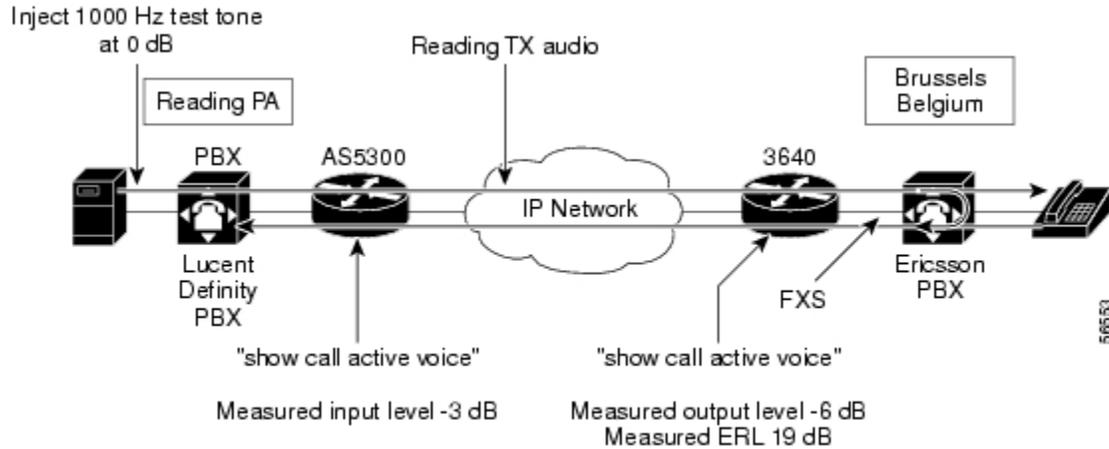
Figure 5 ERL Test Using the FXS Port in Brussels

We ran the same test with the FXS port plugged into the Ericsson PBX, as shown in [Figure 5](#). Note the measured ERL of 19 dB. [Table 2](#) shows output from the **show caller active voice** EXEC command. That call exhibited no echo.

The customer was satisfied with our testing results and decided to use our suggested workaround of using FXS ports, which appeared as CO trunks to the Brussels PBX, out of the Brussels Cisco 3640 router. This solution reduced some of the inward dialing flexibility of the network, but because all inbound calls were handled by an auto-attendant, no functionality was lost.
